**RE: Well Abandonment Activities
York Technical Institute
3050 Hempland Road
Lancaster, Lancaster County, Pennsylvania
Blackstone Project CMSIPA024.08**

Well Abandonment Activities

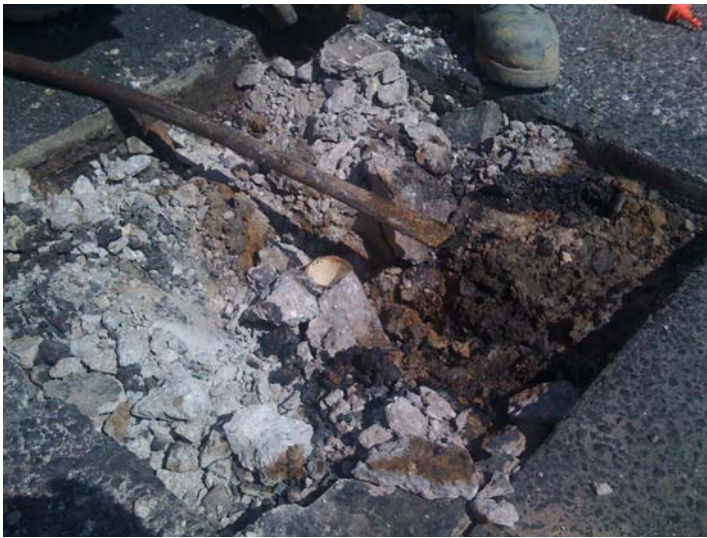
PHOTOGRAPH 1
Location of MW-10 to be abandoned with
manhole removed

- The flush-mount well cover was removed.
- A slurry mixture of Portland cement and bentonite chips poured into each borehole, extending upwards from the bottom of each borehole, until reaching a level just below grade.
- An asphalt patch was then placed on top of each abandoned well location until flush with the parking lot grade.

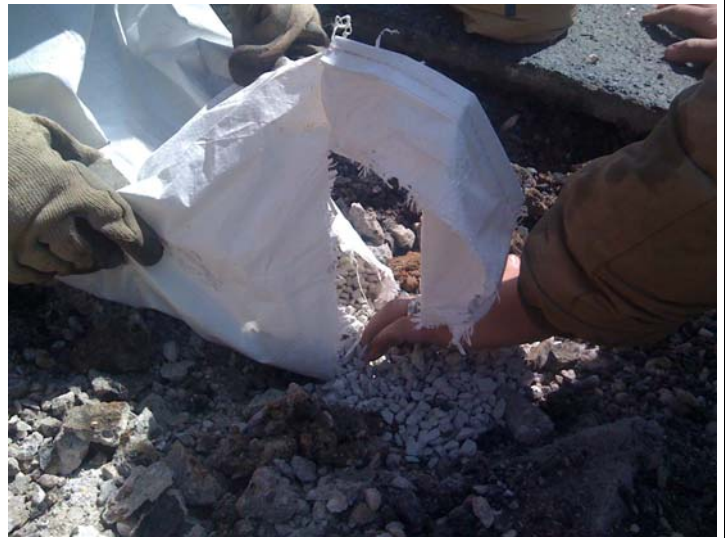
PHOTOGRAPH 2
Topping off location with bentonite chips

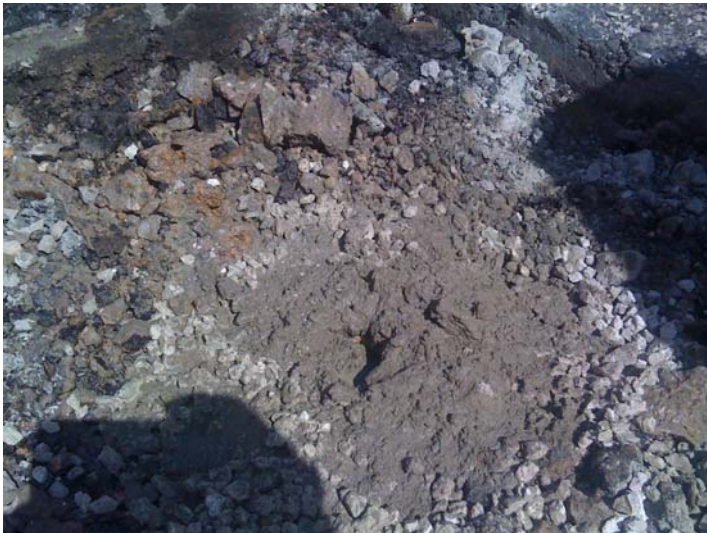
PHOTOGRAPH 3
Borehole ready for surface patch

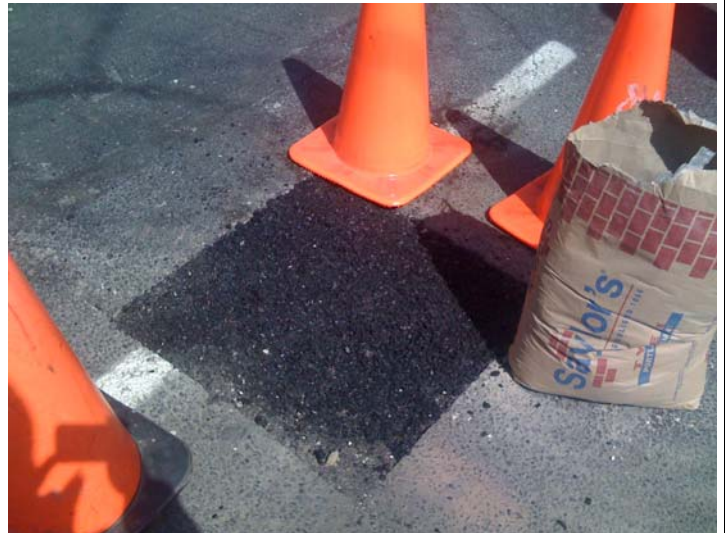
PHOTOGRAPH 4
Completion of closure with asphalt patch
